Burgess Hill Town Memorial and Garden of Remembrance

War Memorials Trust

World War I centenary repairs

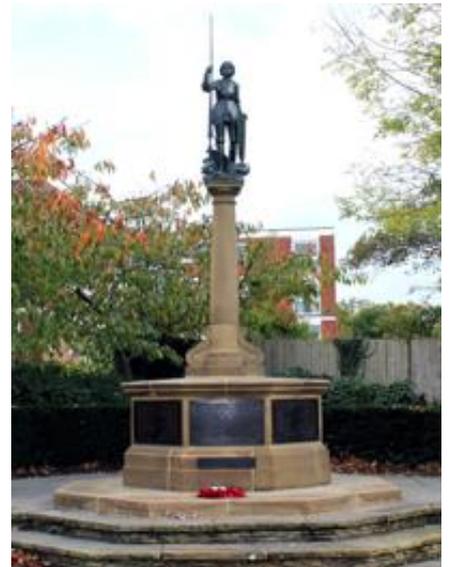
The memorial takes the form of a bronze figure of St George who is armoured except for his bare head. He has a lance in his right hand, a shield in his left and stands over the body of a slain dragon. The figure stands on a circular pillar and octagonal plinth with a three-stepped base made from sandstone.

Burgess Hill town war memorial situated in the Remembrance Gardens © Burgess Hill Town Council, 2018

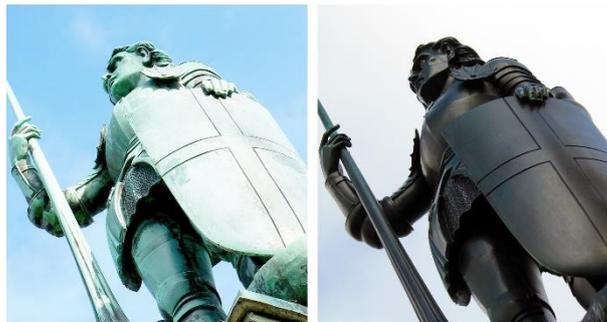
War Memorials Trust was contacted by Burgess Hill Town Council in early 2016 as they felt the town war memorial was in need of urgent repair. Most noticeable was that the statue of St George was leaning slightly. A condition survey/report carried out by a conservation-accredited metal conservator was recommended to inform the necessary conservation and repair works. Deterioration of the stone and bronze elements was a result of exposure to the elements for over 90 years.

Statue of St George before and after works were carried out to Burgess Hill town war memorial
© Burgess Hill Town Council, 2018

Recommendations from the report included removing the statue to stabilise it, cleaning and re-pointing the stonework and works to the bronze dedication plaques to address the slight green discolouration caused by copper sulphate corrosion deposits. New plaque fixings were also suggested to reduce vulnerability theft. The memorial garden gates were also deemed to be rotting and it was recommended that they were replaced. A grant of £12,360 from War Memorials Trust Grant Scheme was awarded which along with additional money from the Town Council meant that these repairs and conservation works could be carried out. In addition the memorial structure was protected by Smart Water a forensic liquid which makes it identifiable if stolen through the [In Memoriam 2014](#) project

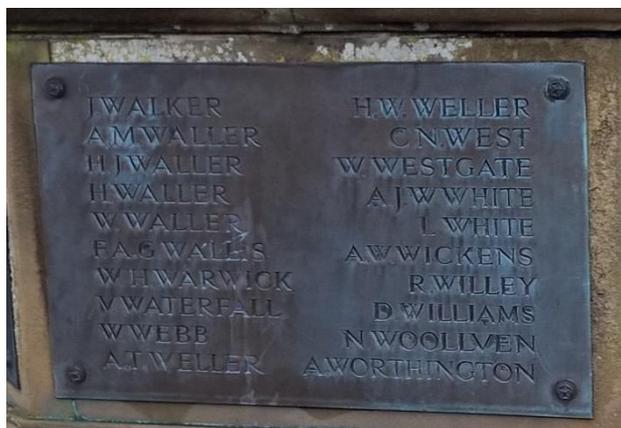
Bronze panel to the left of the inscription on Burgess Hill town war memorial showing Vincent Waterfall's name © War Memorials Trust, 2017
